Damper Flap Issues

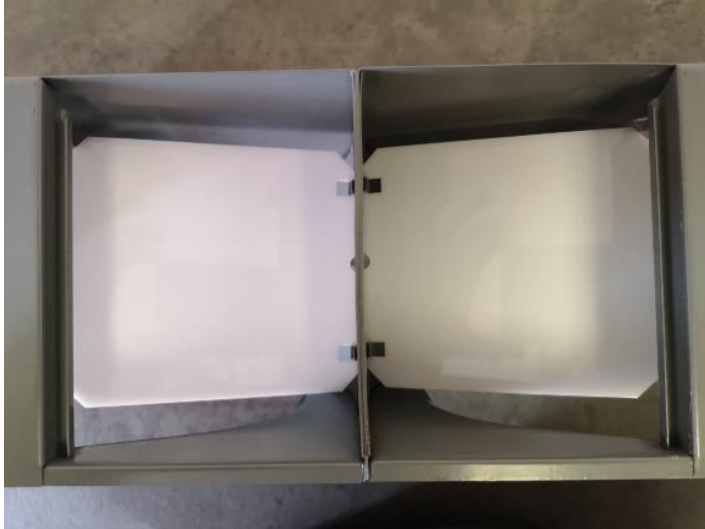
IMPROPER DAMPER POSITION

Improper Position - Top View

If the damper(s) is out of position. Simply push the damper up from the inside so that the damper is sitting in the proper position. (See Images Below) Re-install the blower housing once the dampers are back in the proper position.

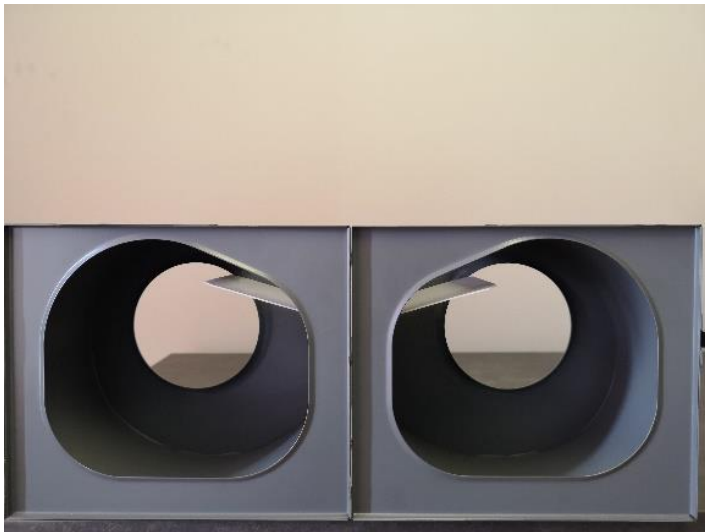
Improper Position – Back View

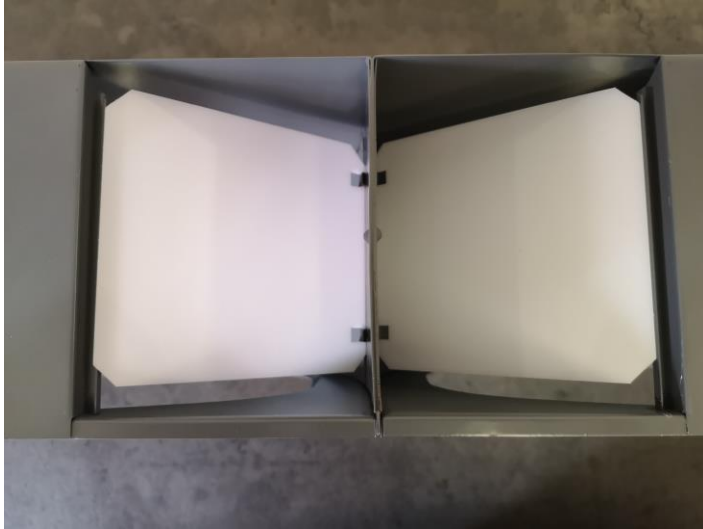
PROPER DAMPER POSTION

Proper Position - Top View

Using the images above ensure that the dampers are in the correct position and are sitting on top of the lip on the housing.

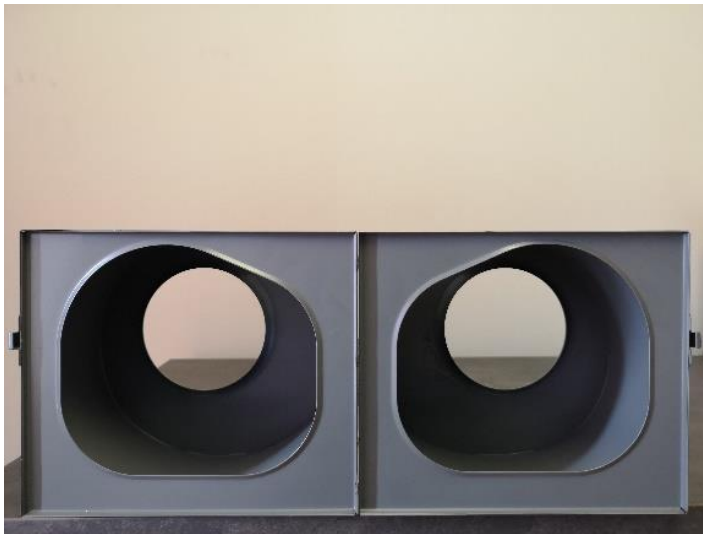
Proper Position – Back View
